IMPORTANT INFORMATION FOR OWNERS AND USERS OF ALL CONTAINERING DESIGN FRAME TANKS MANUFACTURED BY WELFIT ODDY

APPENDIX A : MOUNT INSPECTION PROCEDURE

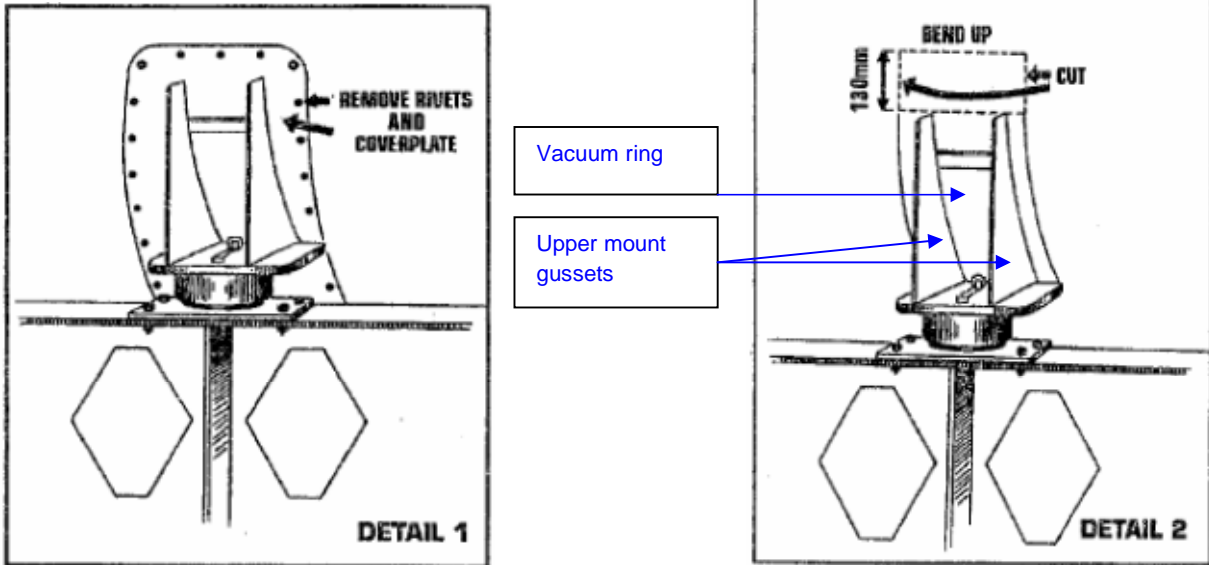
A) UPPER MOUNTS : On all 4 tank mounts, remove the upper cladding cover by drilling out the pop rivets. Cut the aluminium cladding with 2 parallel cuts approx 130 mm from the upper edge of the aperture – this will enable the cladding to be rolled / bent upwards to gain access for inspection. Remove any insulation in the area, and clean by means of wire brush

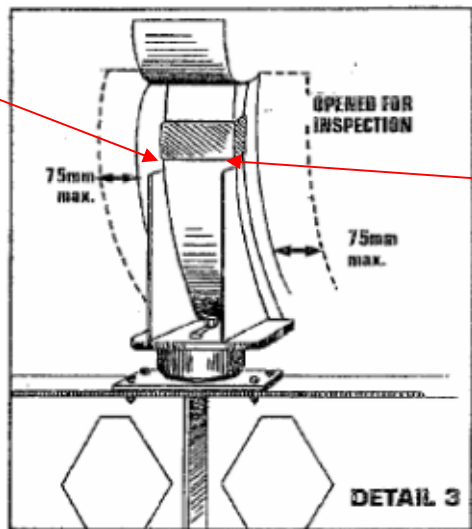
Upper mount inspection point : Inspect for cracks on the front and side wall of the vacuum ring at the top junction of the upper mount gusset and the vacuum ring, and on the tank vessel adjacent to this area

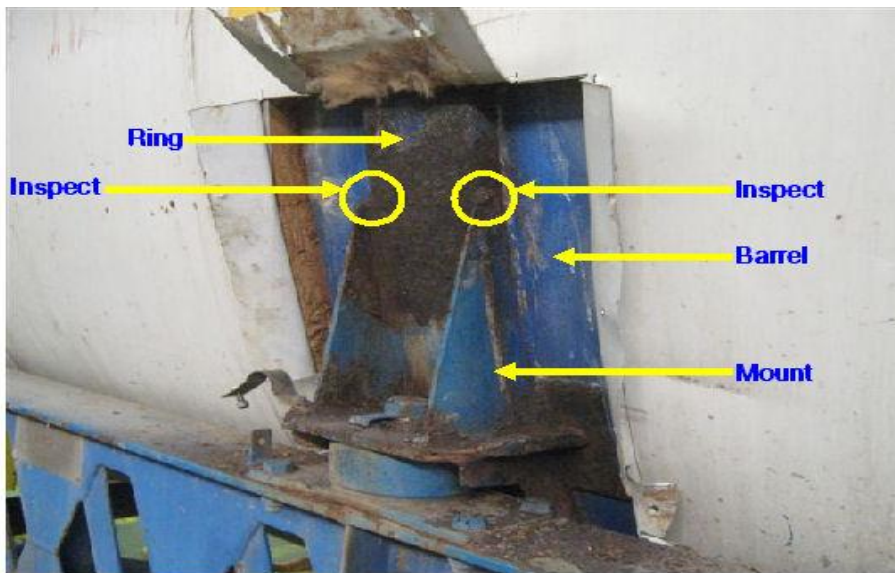
Upper mount inspection point : Inspect for cracks on the front and side wall of the vacuum ring at the top junction of the upper mount gusset and the vacuum ring, and on the tank vessel adjacent to this area

After inspection and any repairs, clean / wire brush the area in preparation for painting. Apply primer using a rust inhibiting primer such as a zinc rich epoxy. Apply top coat in matching colour using an acrylic paint. Reinsulate using mineral wool. Roll down cladding and rivet the cladding cover plates back into position. Re-seal all joints

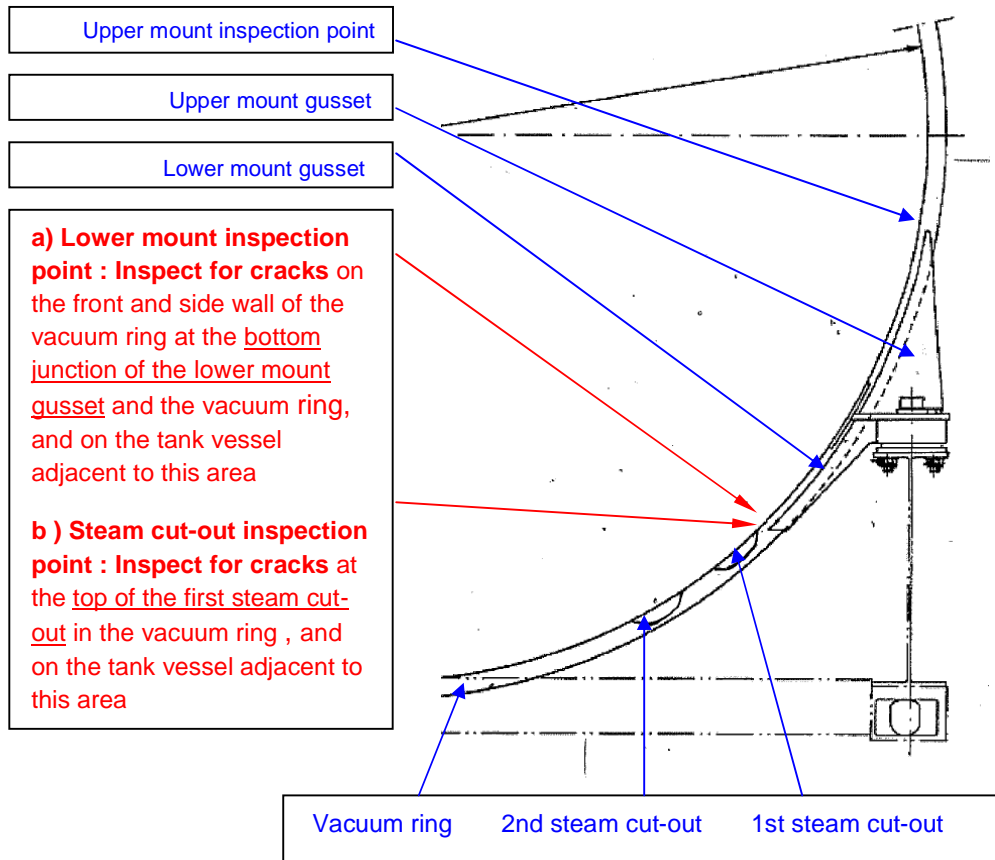
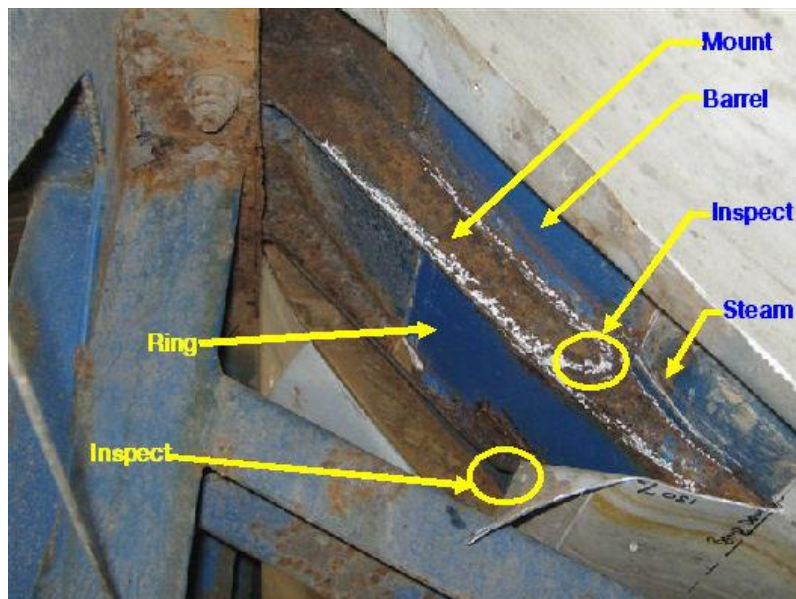
B) LOWER MOUNTS and C) TOP OF THE FIRST STEAM CUT-OUT : The inspection procedure for these areas is a mirror image of that for each of the top mounts.

Remove the cladding panel and insulation , and clean by means of wire brush :
